**Sparta Police Station
Space Needs Analysis Report**

Submitted By
The Blue Ribbon Committee

December 2014

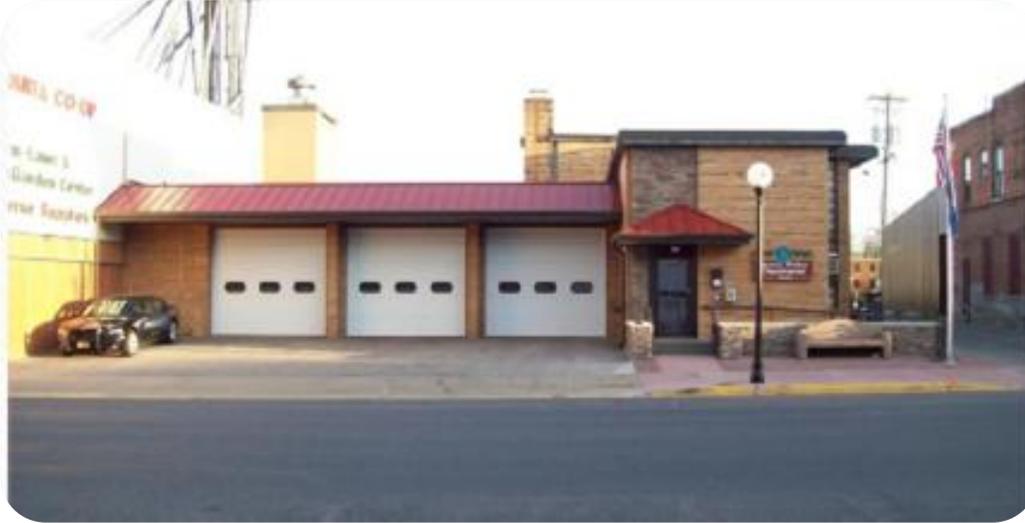
Fig. 2.1

A police building should be considered a law enforcement tool. As with other equipment, productivity, safety and service are reduced when it is inadequate. The existing Sparta Police Department Facility was constructed in 1953. It was originally designed to serve as a Fire Station, Police Station and Jail. The Station contains three floors which totals approximately 11,264 gross square feet (gsf). The intent of the building audit was to help determine if the existing Sparta Police Station could be re-purposed as part of the new facility solution or is the facility inadequate and demolition should be considered. (Fig. 2.1)

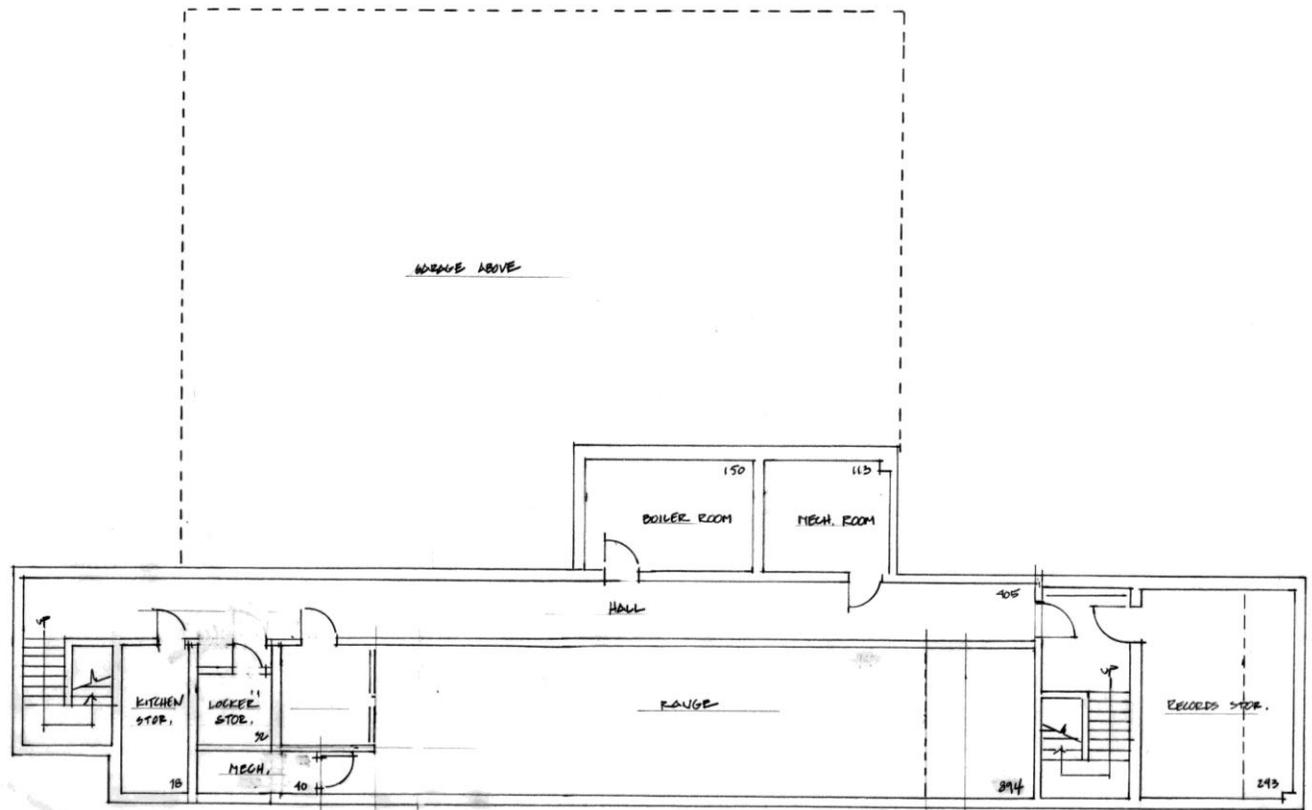
Fig. 2.3

1. Existing Space Inventory - Basement Level = 5719 gsf

The basement level contains the records storage room, firing range and the main mechanical/electrical rooms.

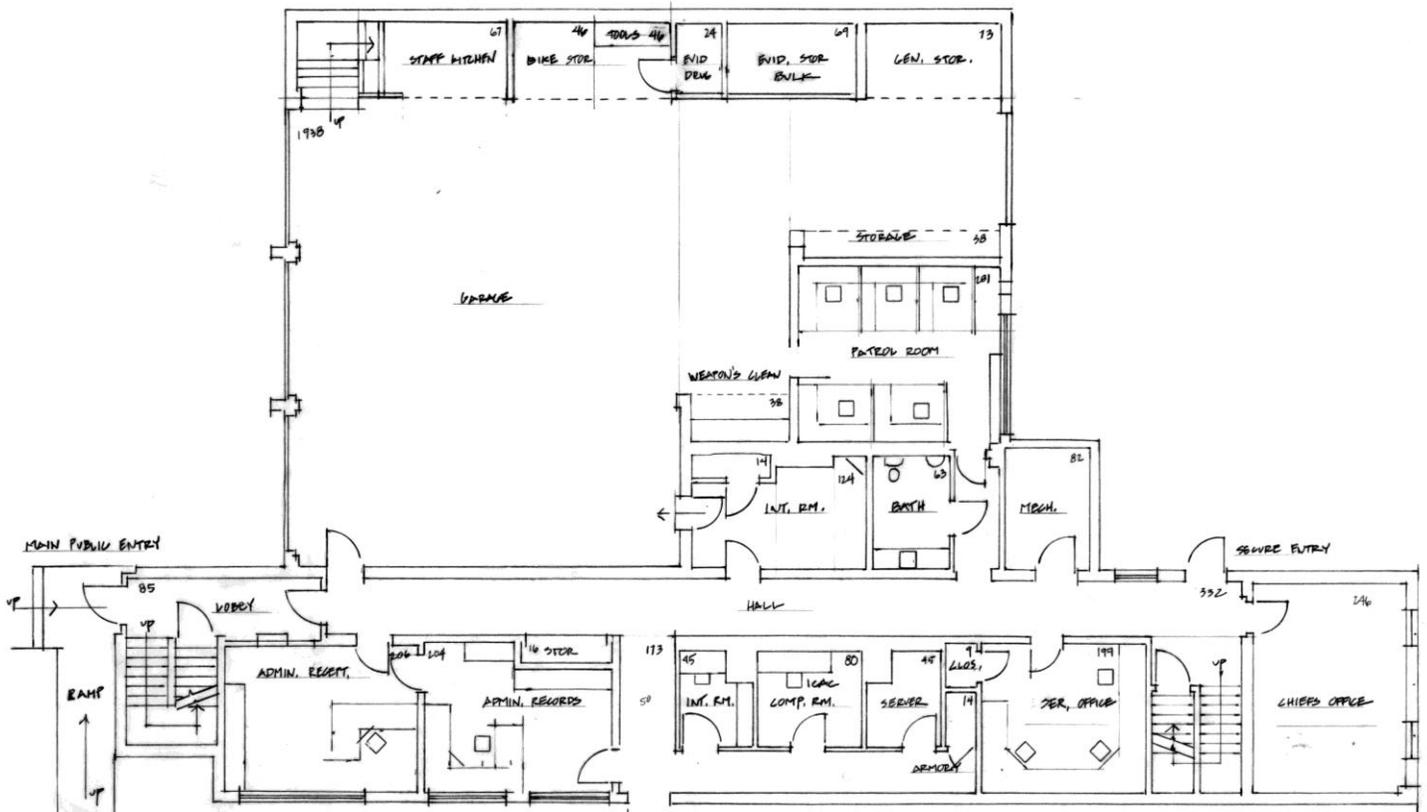
Fig. 2.4

1. Existing Space Inventory - First Floor = 2833 gsf

The ground level floor contains the main public lobby, chiefs and sergeants offices, patrol officer workstations, administrative areas, soft/hard interview rooms, evidence storage, records storage, armory, vehicle garage, staff break area and mechanical room.

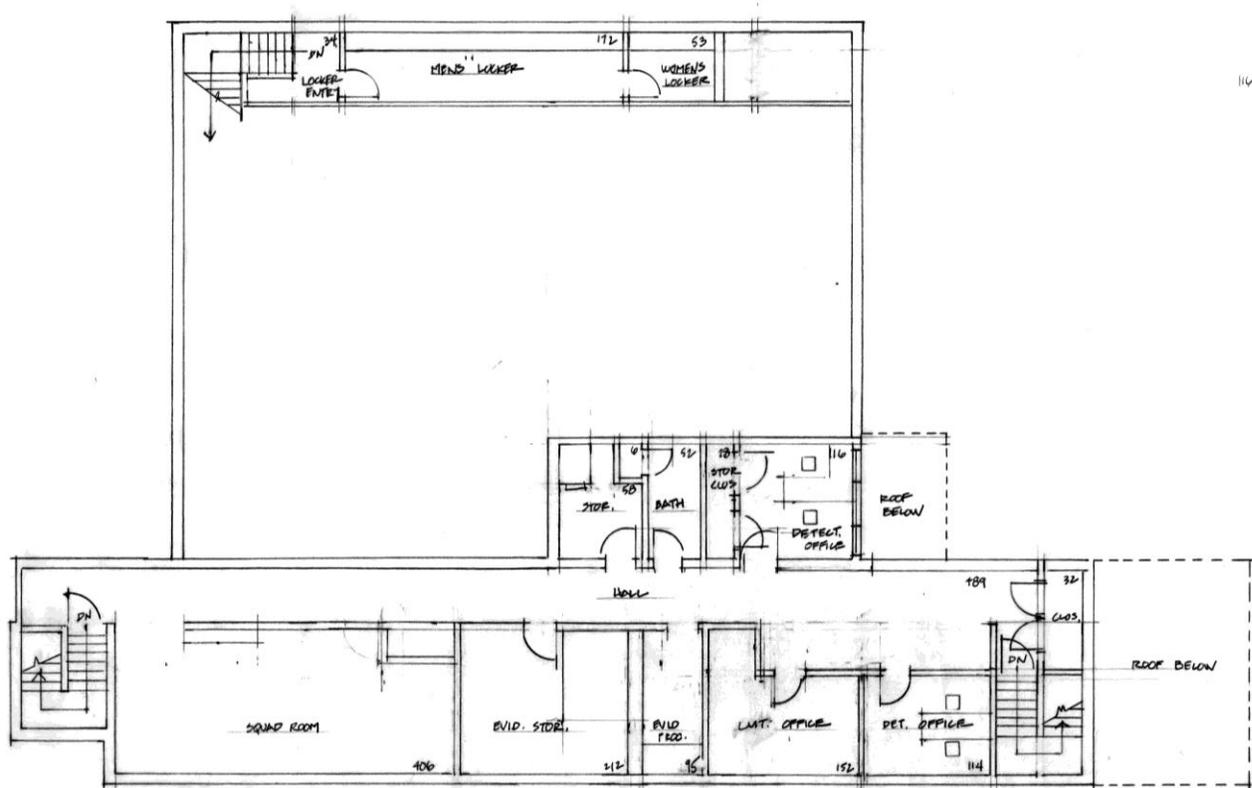
Fig. 2.5

1. Existing Space Inventory - Second Floor = 2712 gsf

The second floor contains the squad room, detective and lieutenants offices, evidence processing, storage rooms, the men's and women's lockers/showers, (accessible from the first floor) and mechanical rooms.

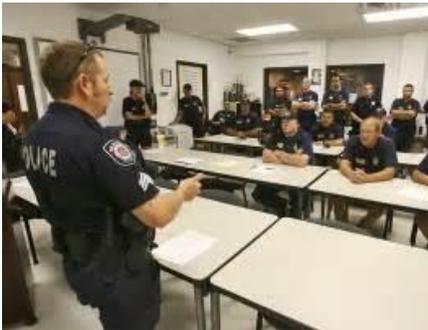
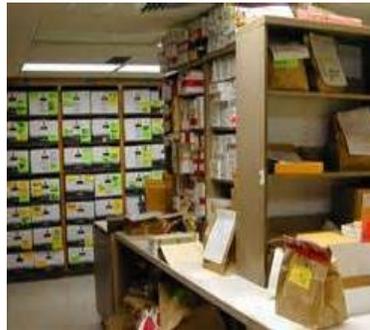
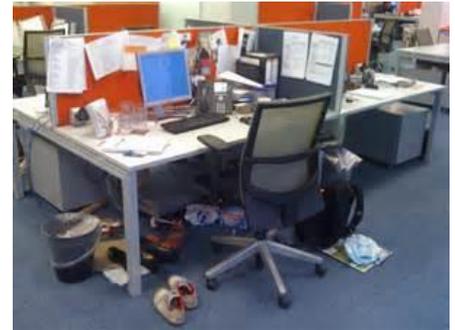
- **Consumer Friendly**
 - Front door image is not customer friendly or “welcoming”
 - No seating or waiting area for the public
- **Time Inefficiencies**

- Off-site impound garage location causes officers to take multiple trips back and forth
 - Dispersed vs. consolidated evidence rooms leads to work inefficiencies as well as conducting poor evidence processing

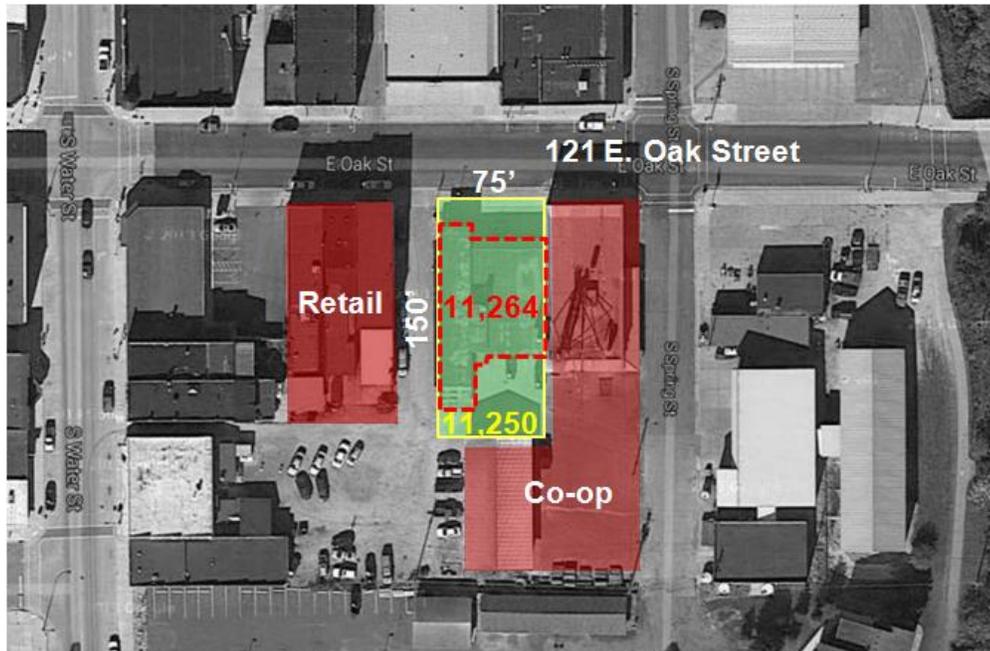
Fig. 3.1

The existing site is 75' x 150' equaling 11,250 feet or .2 acres. (Fig. 3.1 Green Area) The red dashed line indicates the footprint of the existing 3 level SPD facility which contains approximately 11,264 gsf. The property is bounded to the east by a Co-op facility and three retail establishments to the west. The properties east and west of the SPD may be considered for acquisition. (Fig. 3.2)

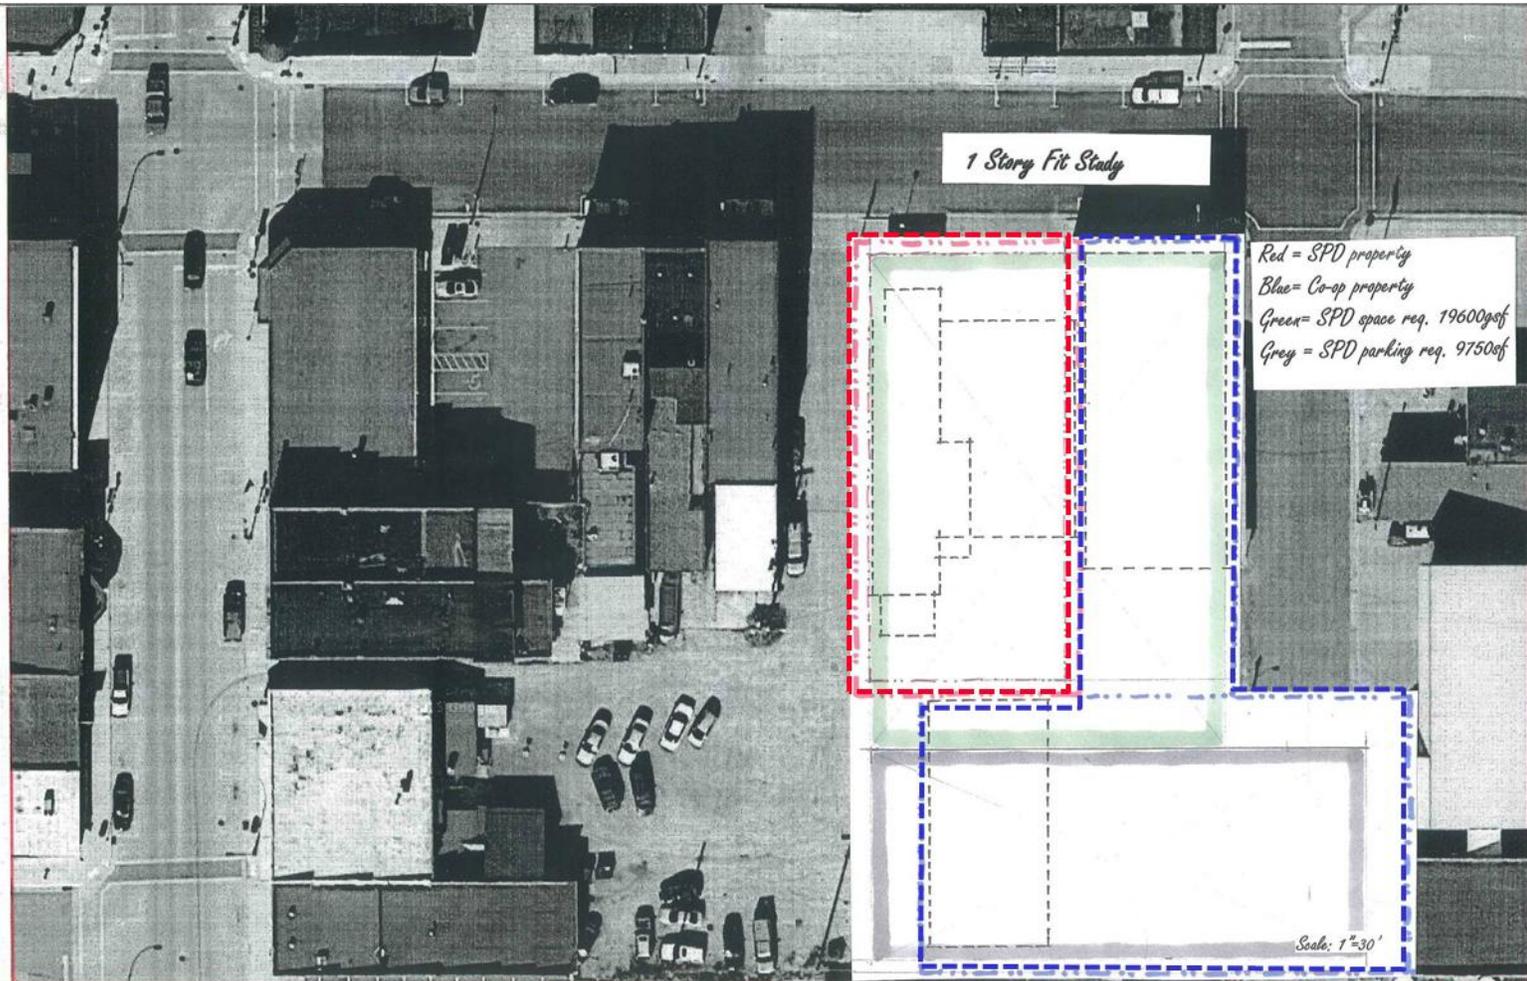
Fig. 5.1

The aerial photo below (Fig. 5.1) shows the location of the current SPD on 121 E. Oak Street. The red dashed line indicates the property line of the existing SPD while the blue dashed line indicates the adjacent Co-op property line.

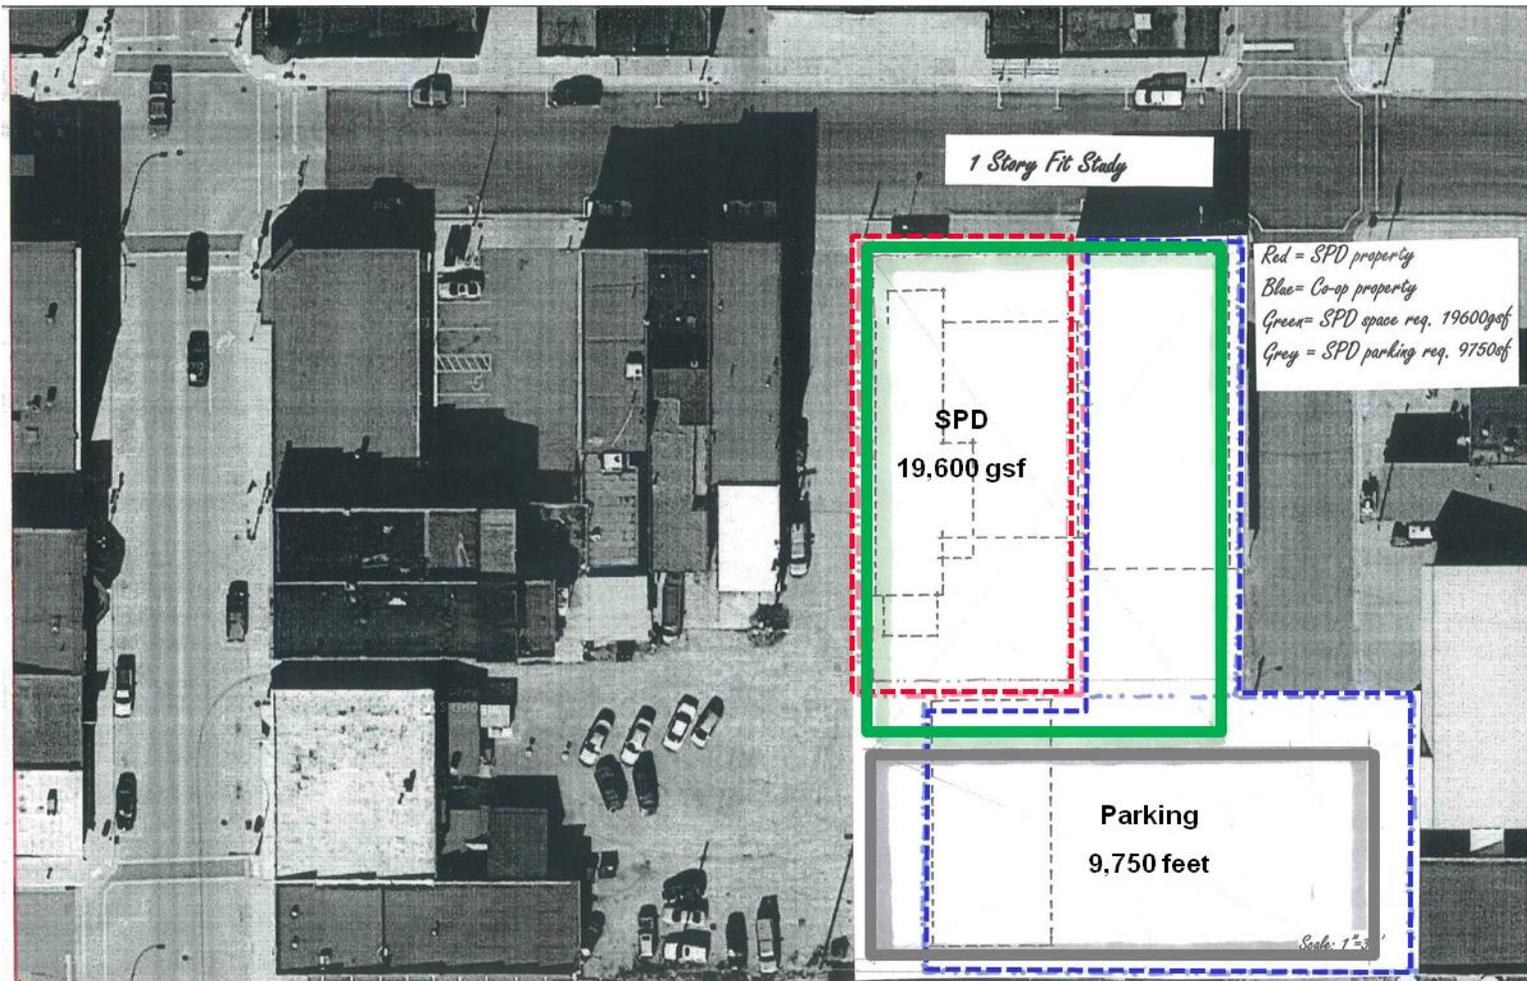
Fig.5.2

Fig. 5.2 illustrates a one story facility site fit study. Using the forecasted 19,600 gsf for the SPD, the facility footprint (green line) and parking requirement of 9750 feet (grey line) exceeds the current SPD property line (red dashed line). The site fit study indicates that to use the existing site for a single story SPD facility would require property acquisition.

The red dashed line indicates the buildable area of the existing SPD site
The blue dashed line indicates the property line of the adjacent Co-op property

The outcome of the site fit study indicates that **the current SPD site will not accommodate the year 2040 space requirements projection of 19,600 gsf and additional property adjacent to the current site would be required.** (Fig. 5.2 - Fig. 5.3)

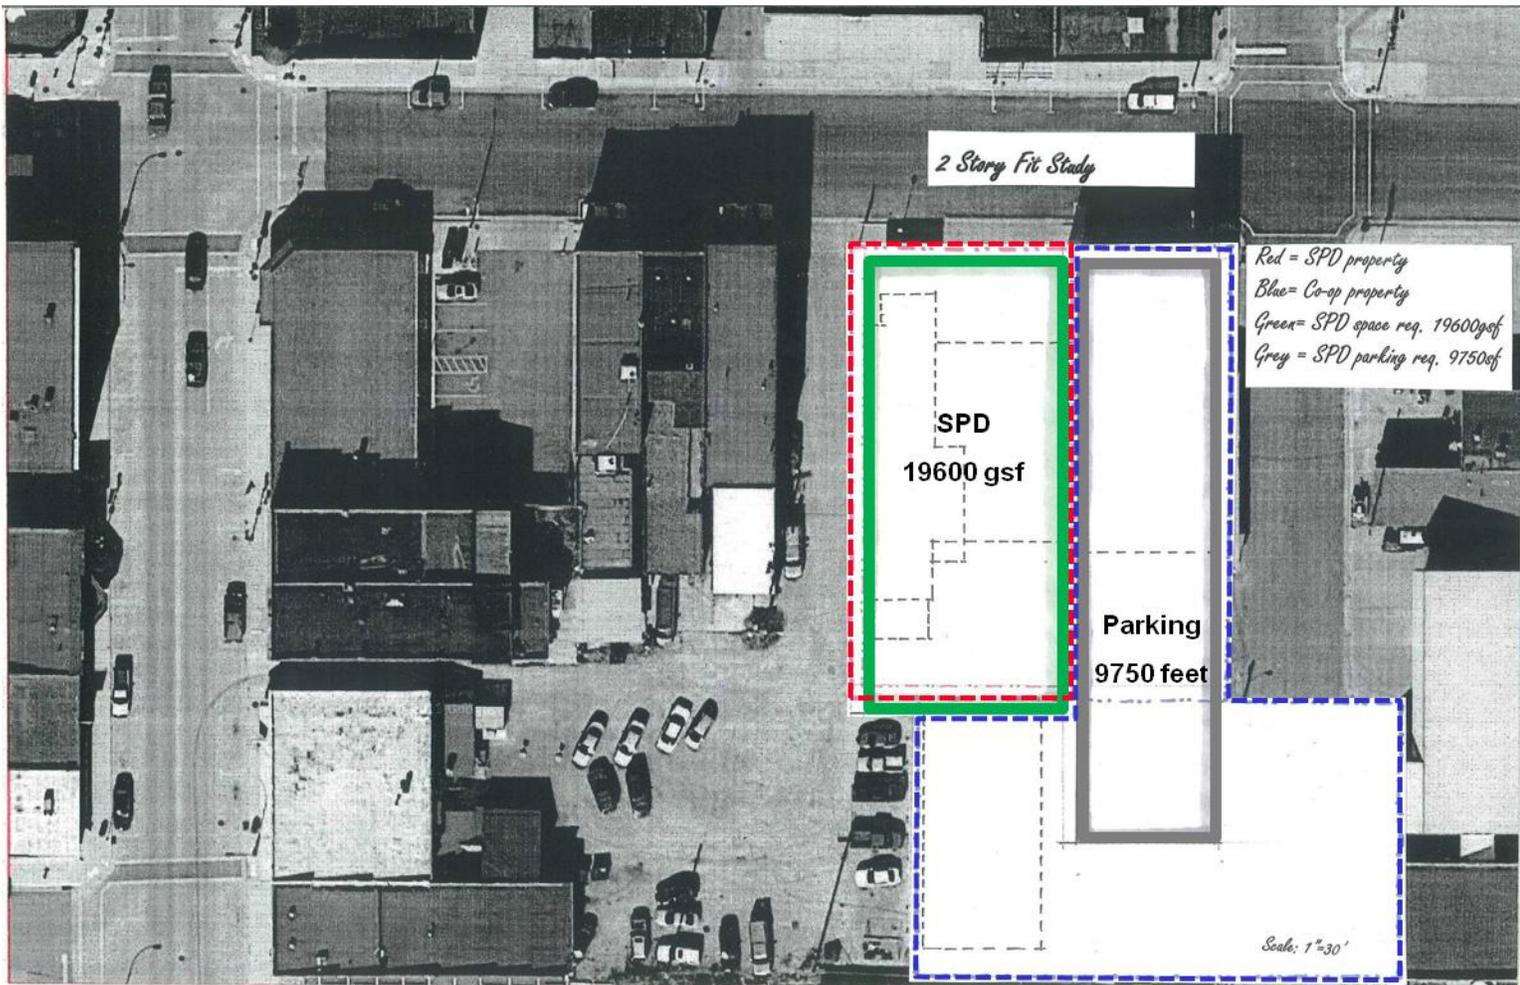
Fig. 5.3 illustrates a two story facility site fit study. Using the forecasted 19,600 gsf for the SPD, the facility footprint/9800sf per floor (green line) and parking requirement of 9750 feet (grey line) also exceeds the current SPD property line (red dashed line). The site fit study indicates that to use the existing site for a two story SPD facility would require property acquisition.

The red dashed line indicates the buildable area of the existing SPD site
The blue dashed line indicates the property line of the adjacent Co-op property

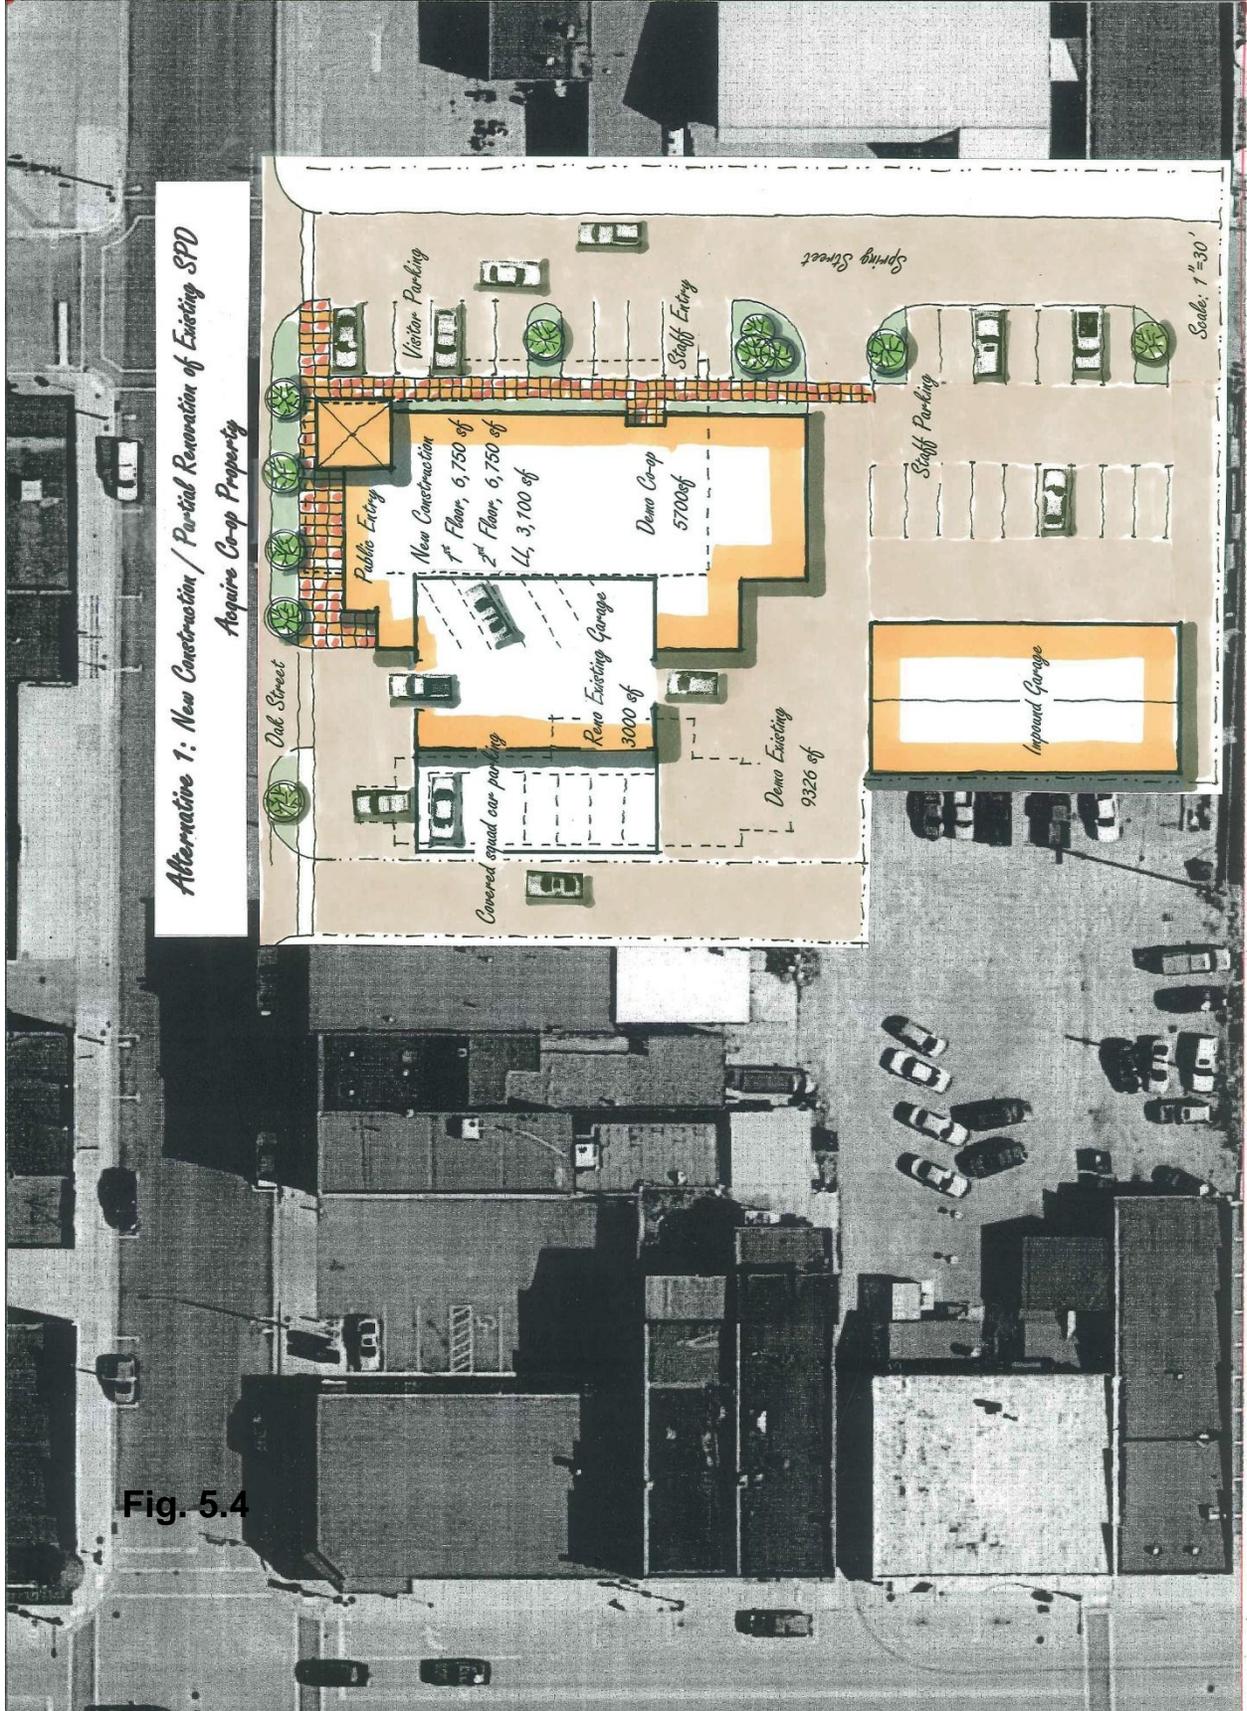
Fig. 5.4

ALTERNATIVE 1 – Site/Facility Master Plan

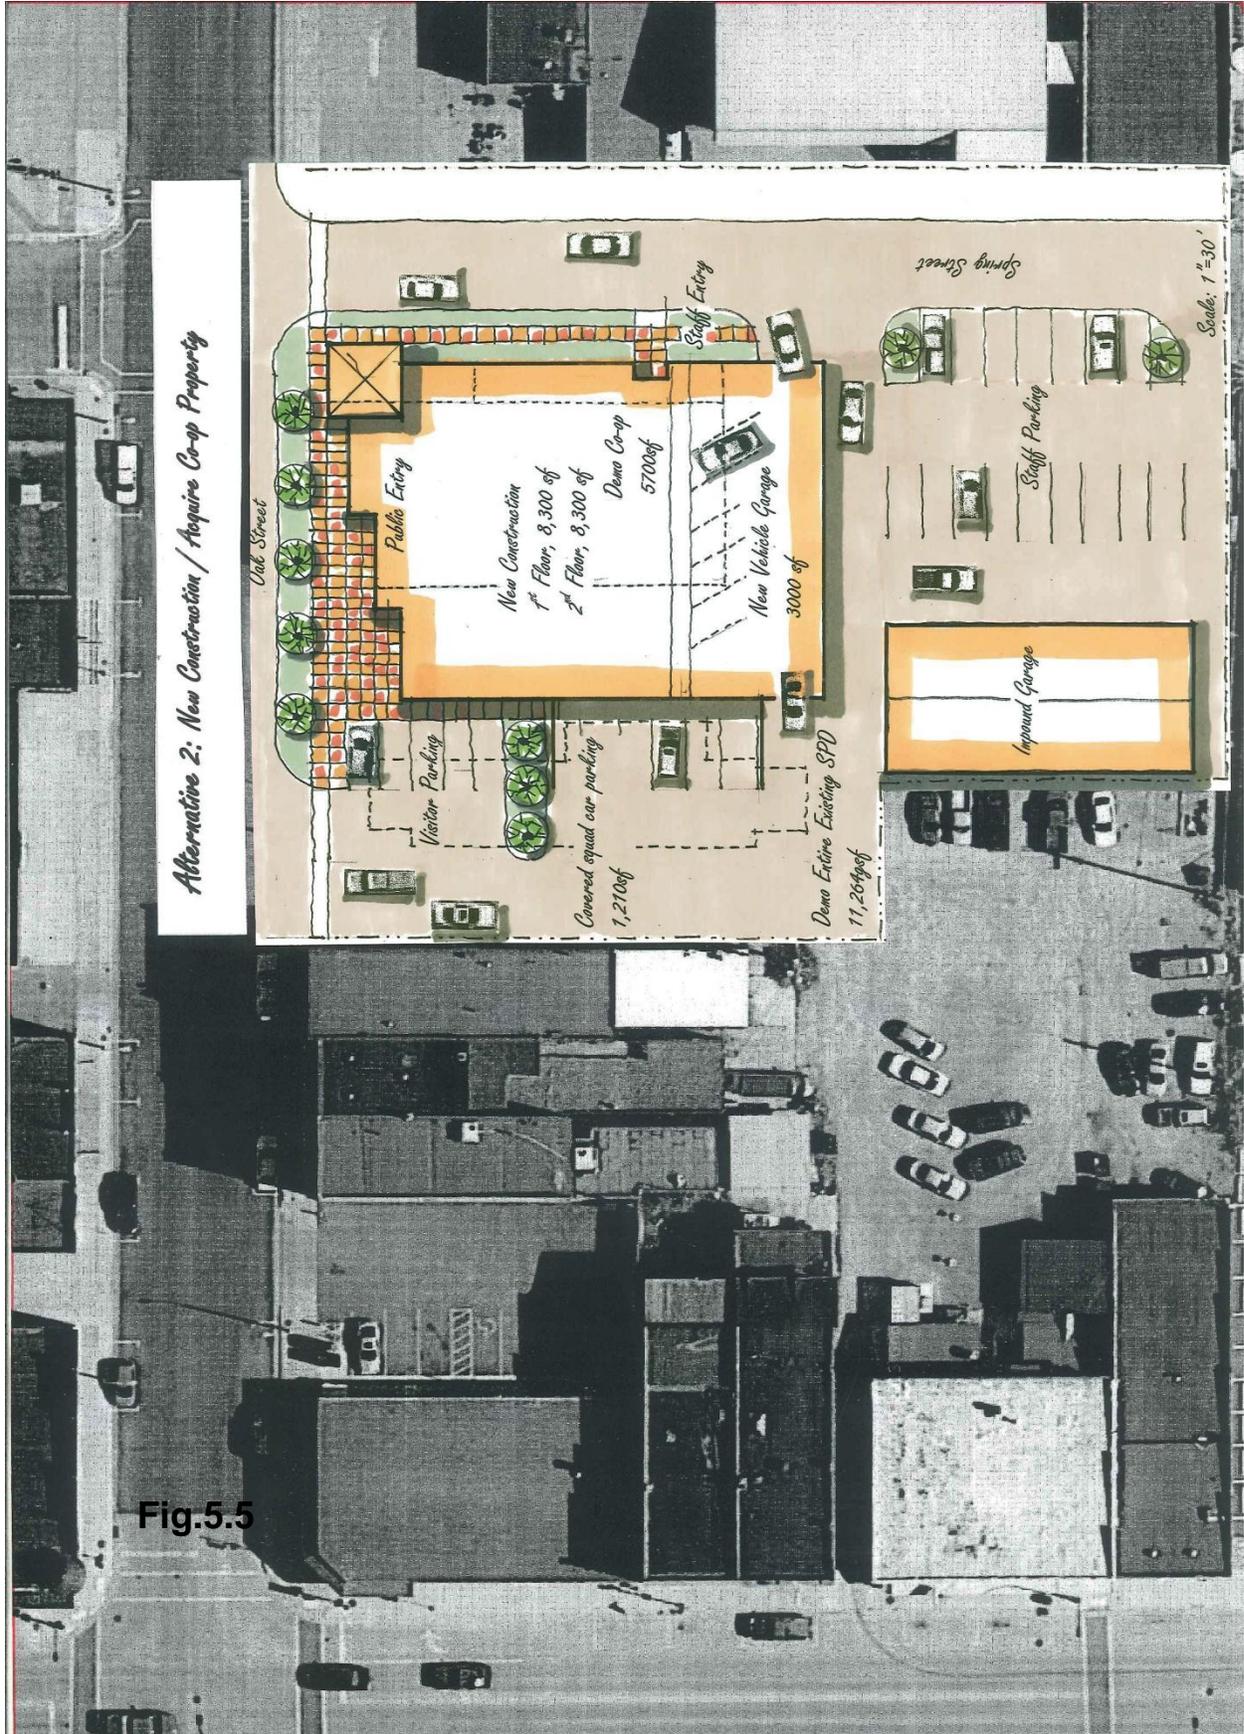
Fig.5.5

ALTERNATIVE 2 – Site/Facility Master Plan

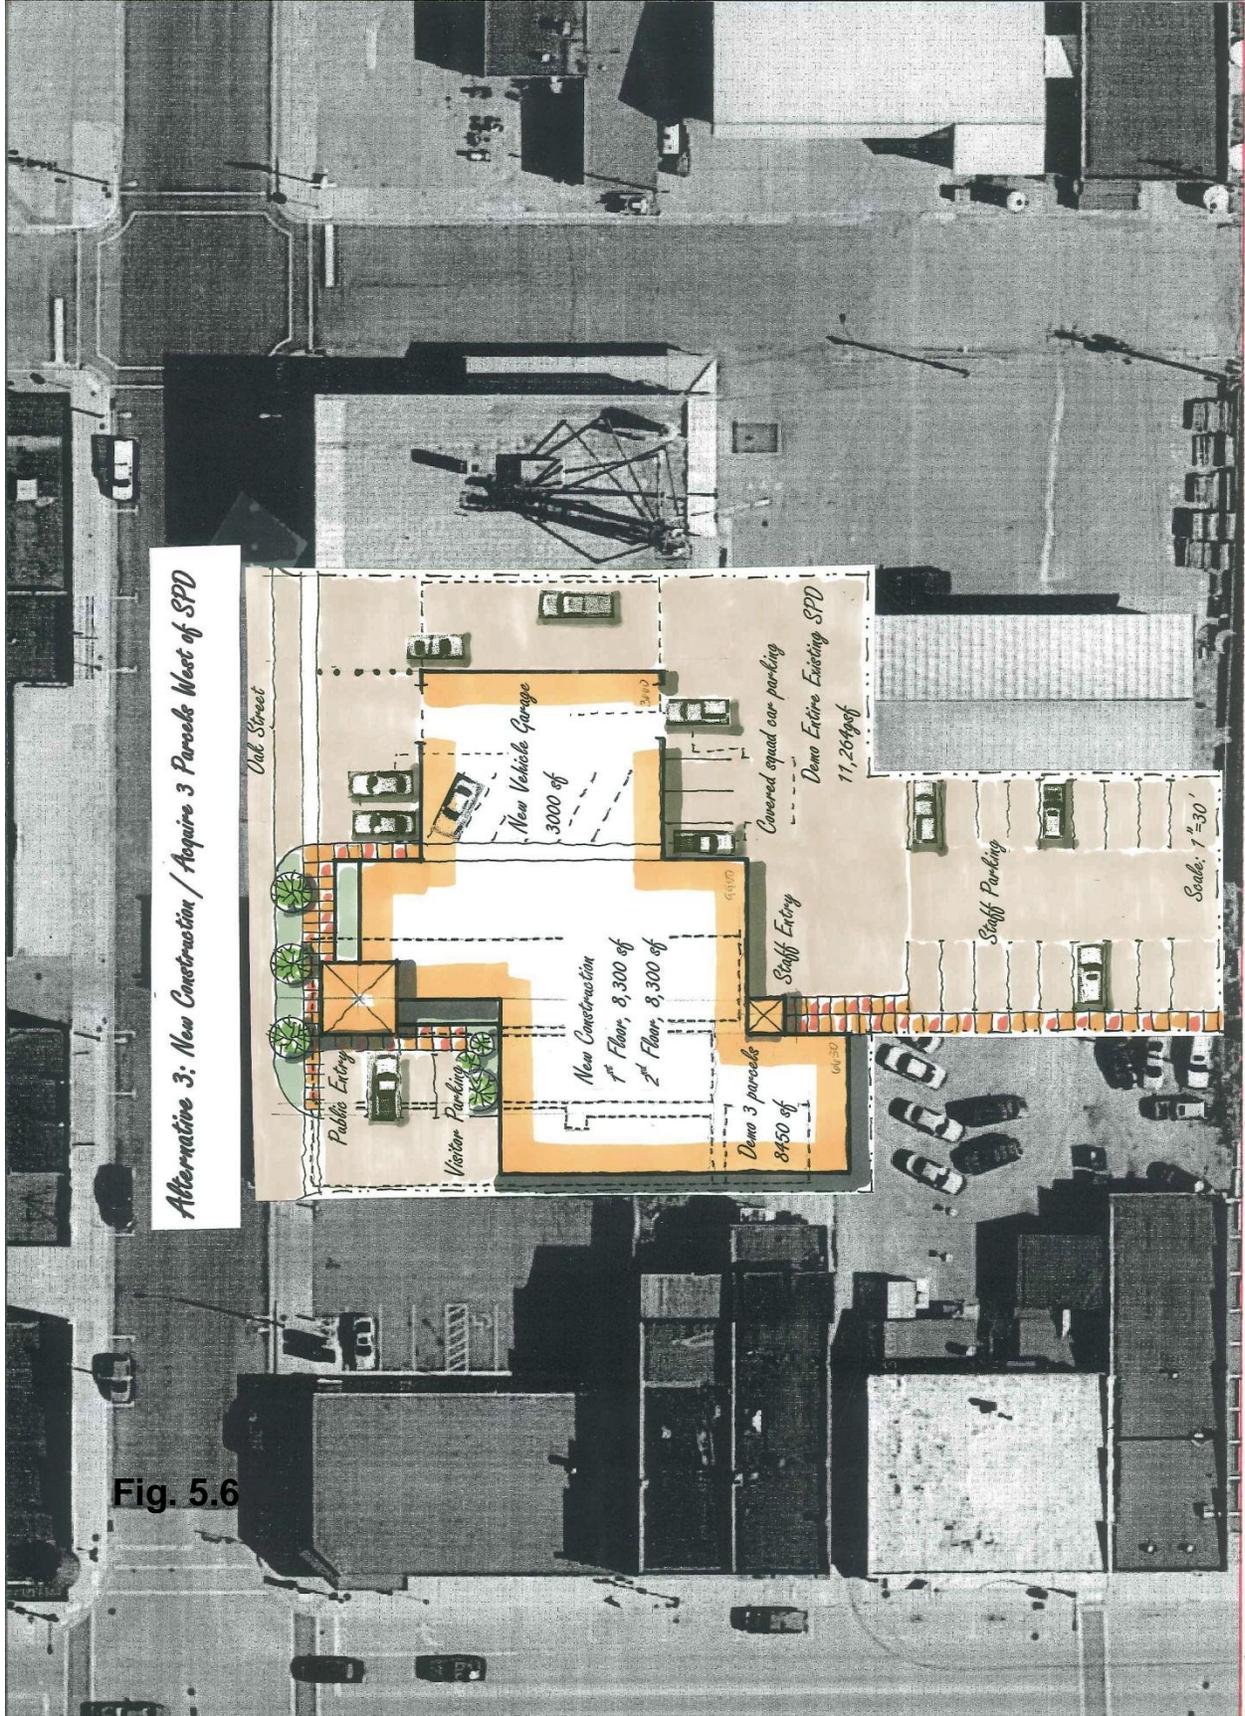
Fig. 5.6

ALTERNATIVE 3 – Site/Facility Master Plan

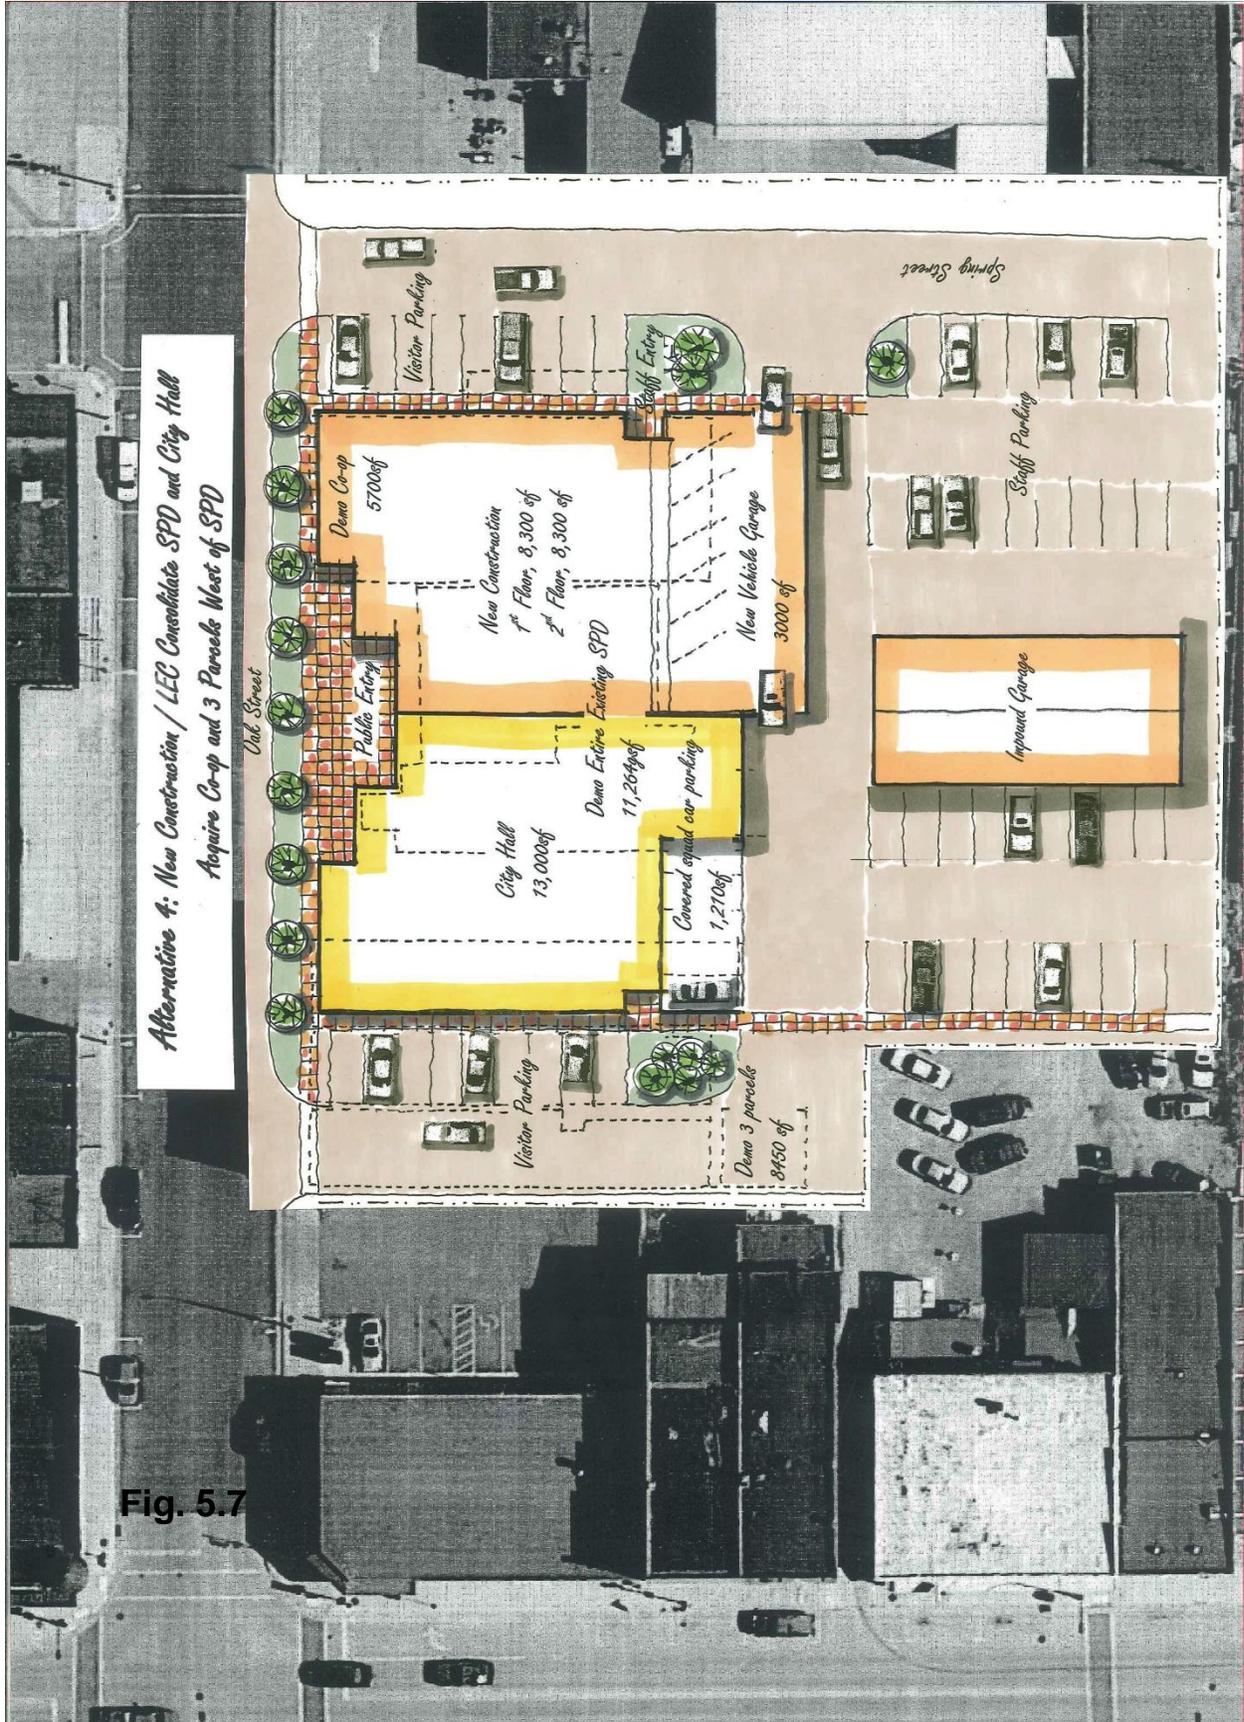
Fig. 5.7

ALTERNATIVE 4 – Site/Facility Master Plan

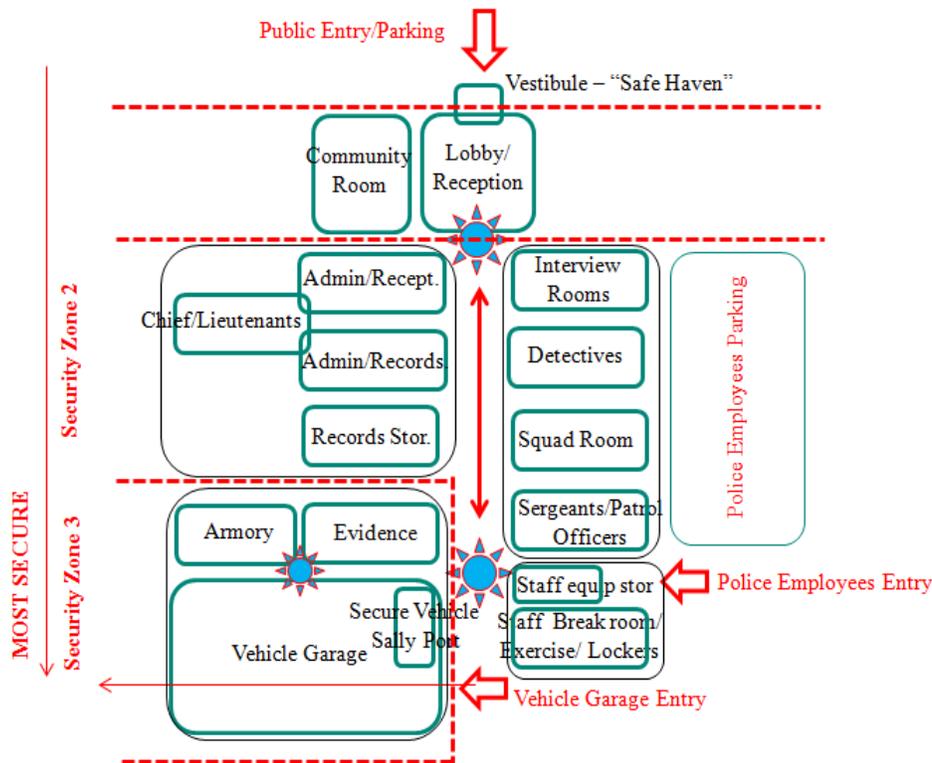
Fig. 5.7

A police station proto-type concept was developed with the SPD staff to establish the security, and space adjacency requirements between the different facility components. The proto-type concept (Fig. 5.7) was used to generate the two “Green Field” site/facility land use plan alternatives.

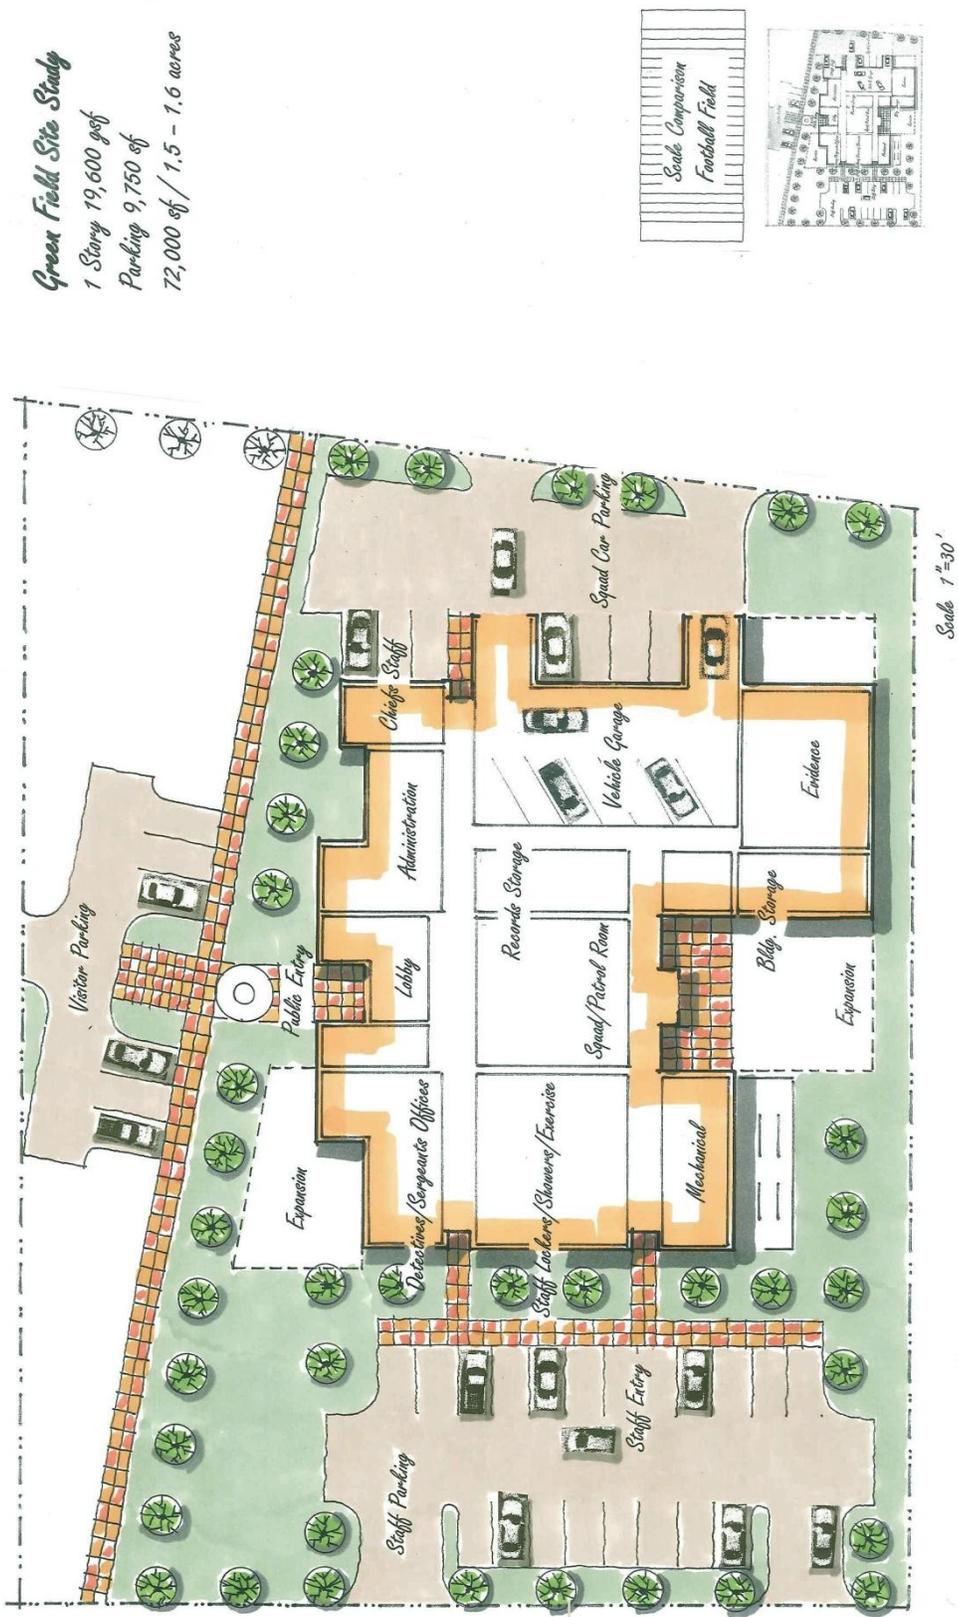
Fig.5.8

ALTERNATIVE 5 – Site/Facility Master Plan (1 Story)

Alternative 5, (Fig. 5.8 and Fig. 5.9) new construction on a “Green Field” site have been developed in the event that the City of Sparta determines that the existing 121 E. Oak Street SPD site is not a good fit. The following one and two story police station alternatives were developed to demonstrate what the site requirements would be for a “Green Field” facility approach.

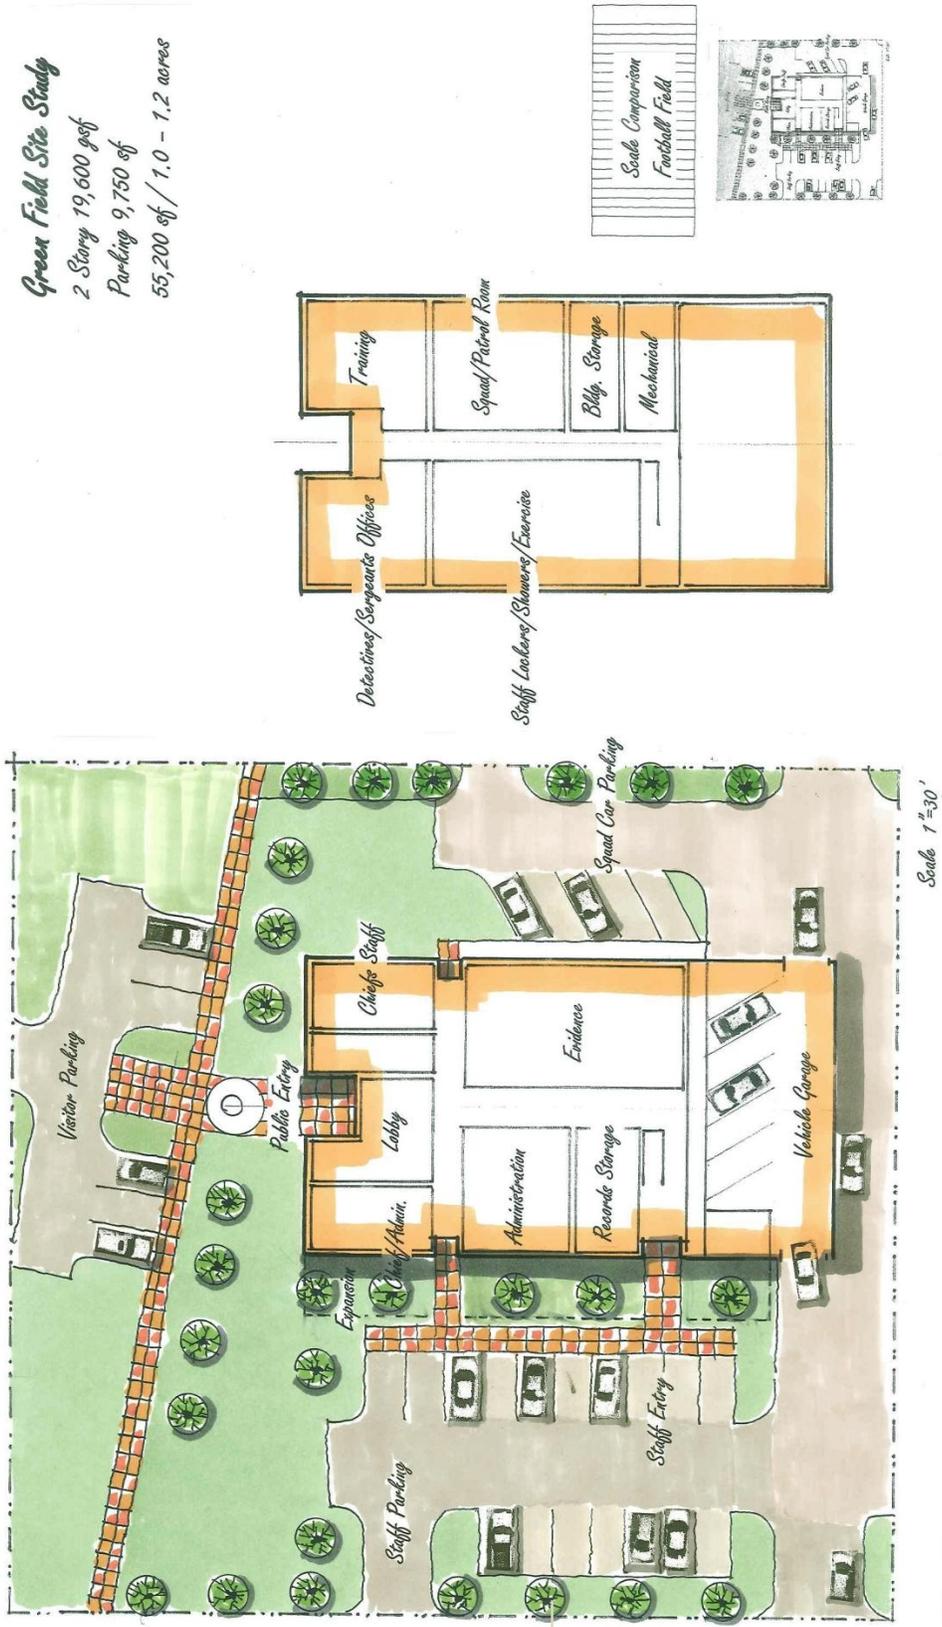
Fig. 5.9

ALTERNATIVE 5 – Site/Facility Master Plan (2 Story)
