**Sparta Police Station
Space Needs Analysis Report**

Submitted By
The Blue Ribbon Committee

December 2014

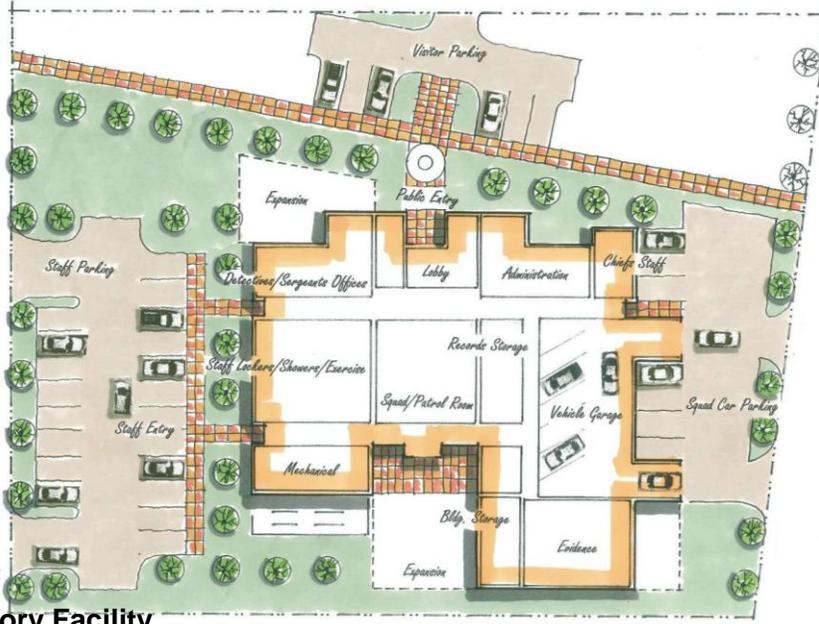
1 Story Facility

Green Field Site Study
 1 Story 19,600 gsf
 Parking 9,750 of
 72,000 of / 1.5 – 1.6 acres

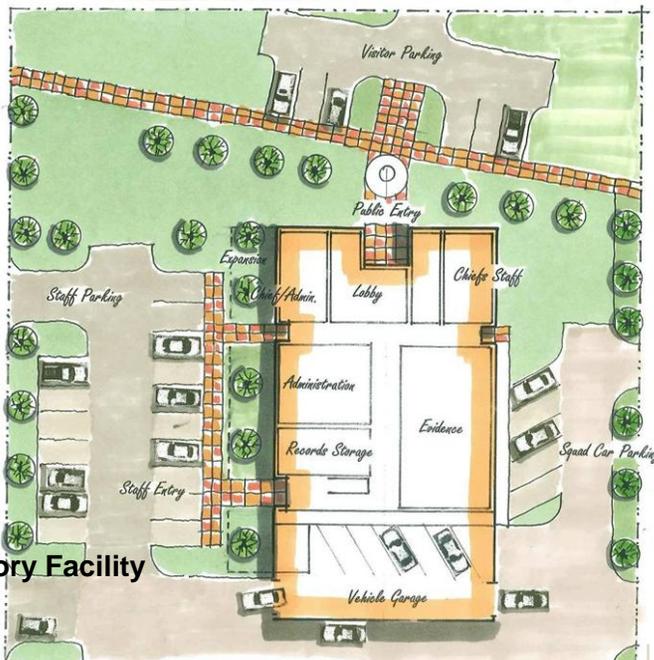
2 Story Facility

Building gsf = 19,600gsf or 9,800gsf/floor
 Parking Area = 9,750 feet
 Total Lot Size = 55,200 feet or 1.0 – 1.2 acres

Green Field Site Study
 2 Story 19,600 gsf
 Parking 9,750 of
 55,200 of / 1.0 – 1.2 acres
